Bondlines – Online blade measurements (October 2012 and January 2013)

Department of Wind Energy E Report 2013

DTU Wind Energy E-0036

The BONDLINEs project (EUDP File Number 64012-0128) is subtitled “Regain the operational life time of installed WTG blades with structural defects”. The Objective is to develop, prepare for market and demonstrate an applicable method for regaining operational life of installed wind turbine blades with structural defects based on patented technologies (Bladena) for limiting deformations in panels. In the project this method will be demonstrated on a turbine in operation. The solution will remove the root cause for bond line defects, which are the dominant defect on blades.

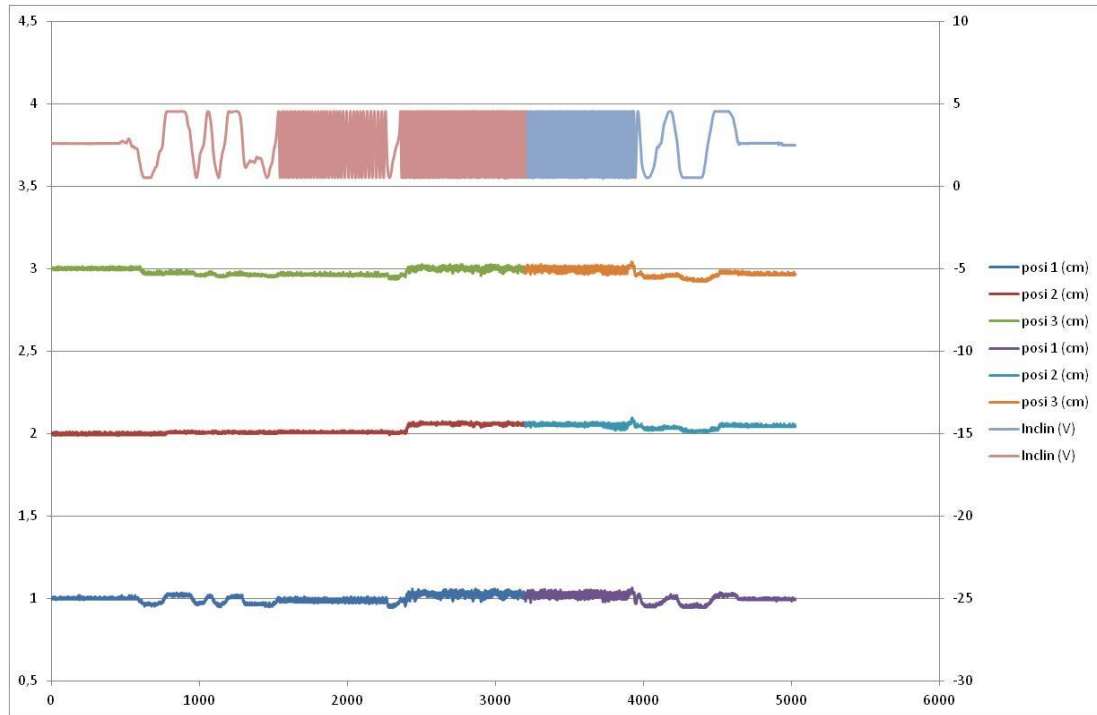
Fig. 64 - Main trace for the 130110 Test 1 showing the full acquisition period

At around 500s the blade is rotated from the 0° to 90°, and then on to 270°. After a brief start up period the turbine is rotated at a pitch angle of 50 deg between 1500 and 2300s. The blade is then placed in full run condition with a pitch value between -1 and 2 deg until approximately 4000s. At the switch to autorun condition there is an approximately 1mm step up observed in all the posiwire outputs. After the autorun condition is over the blade is again cycled to hold periods at 90°, 270°, and then 0°. Pitch changes at the horizontal blade holds caused no effect on the poiswire outputs.

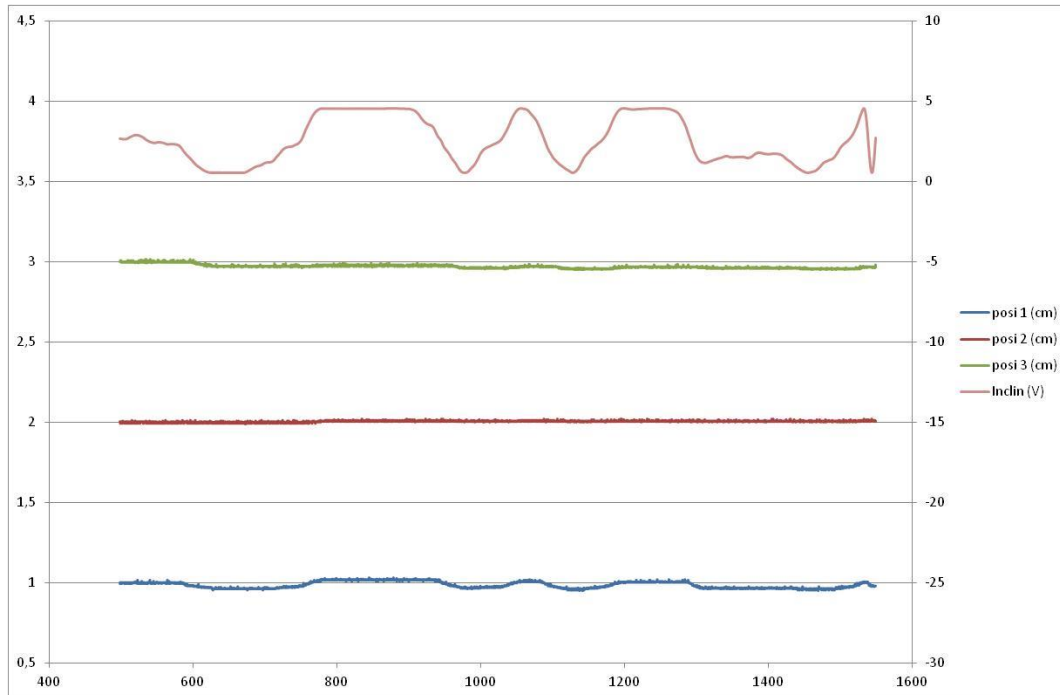
Fig. 65 – Detail from 130110 Test 1 showing the start up

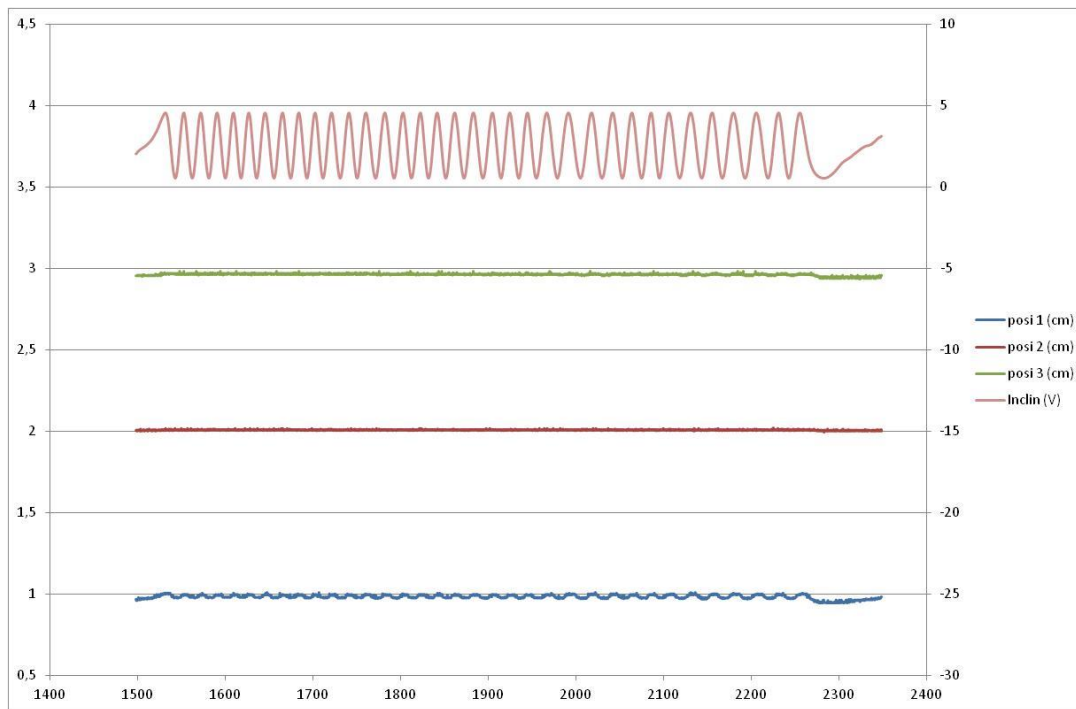
Fig. 66 – Detail from 130110 Test 1 showing turbine running at 50 deg pitch angle

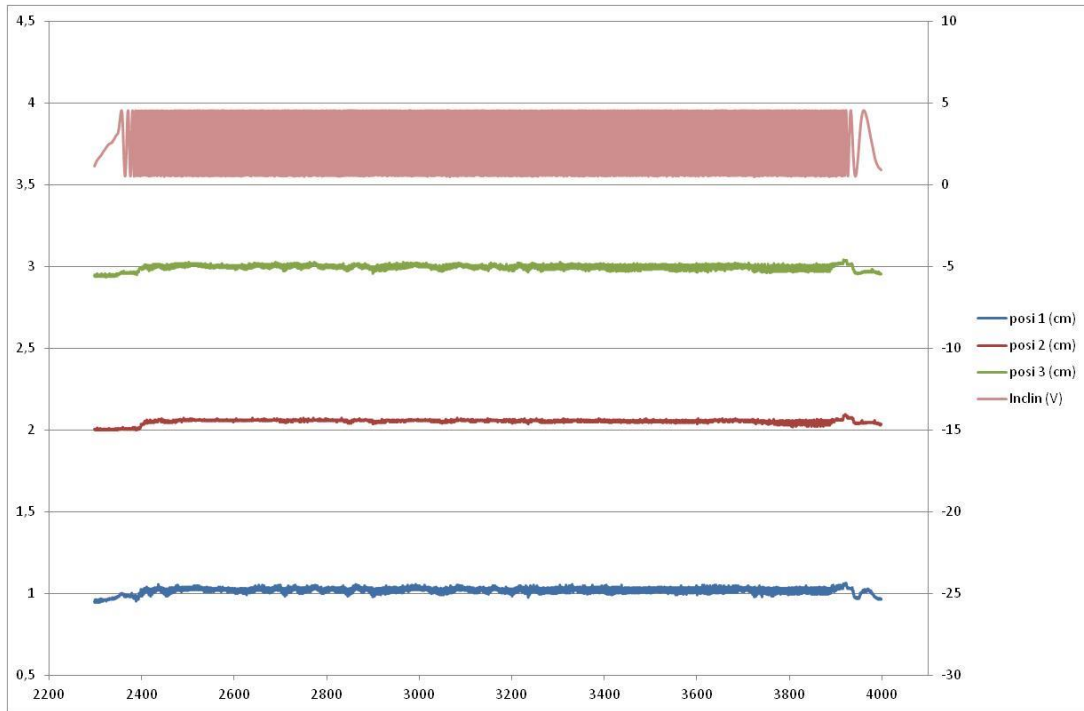
Fig. 67 – Detail from 130110 Test 1 showing turbine during autorun at -1 to 2 deg pitch angle

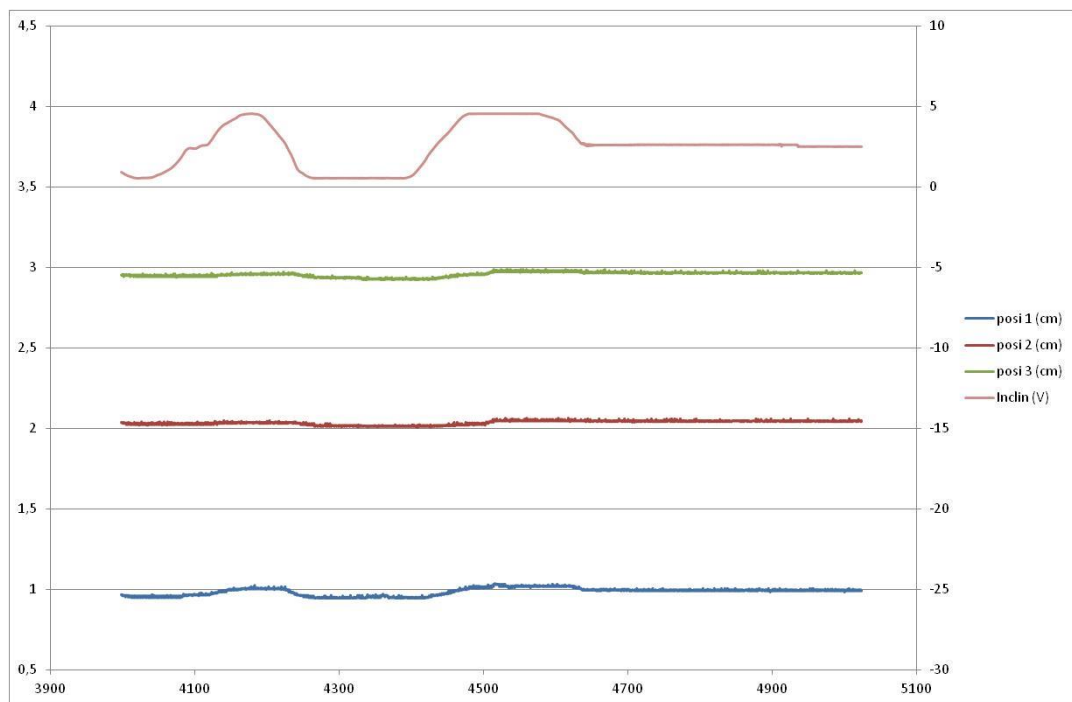
Fig. 68 – Detail from 130110 Test 1 showing effect of pitch change (0-90-0 deg) during horizontal blade hold

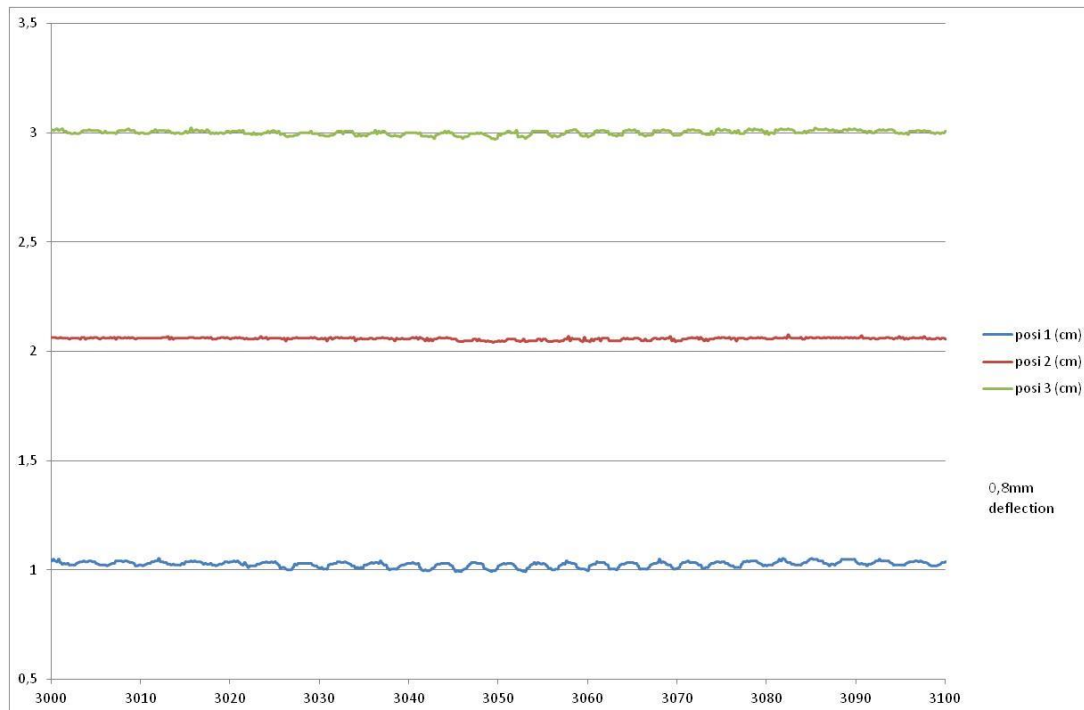
Fig. 69 – Close up detail from 130110 Test 1 showing posiwire response during autorun (-1 to 2 deg)

During autorun condition the posiwire response is very limited (under 1 mm total deflection) although in detail it is possible to see the cyclic response due to the blade rotation.

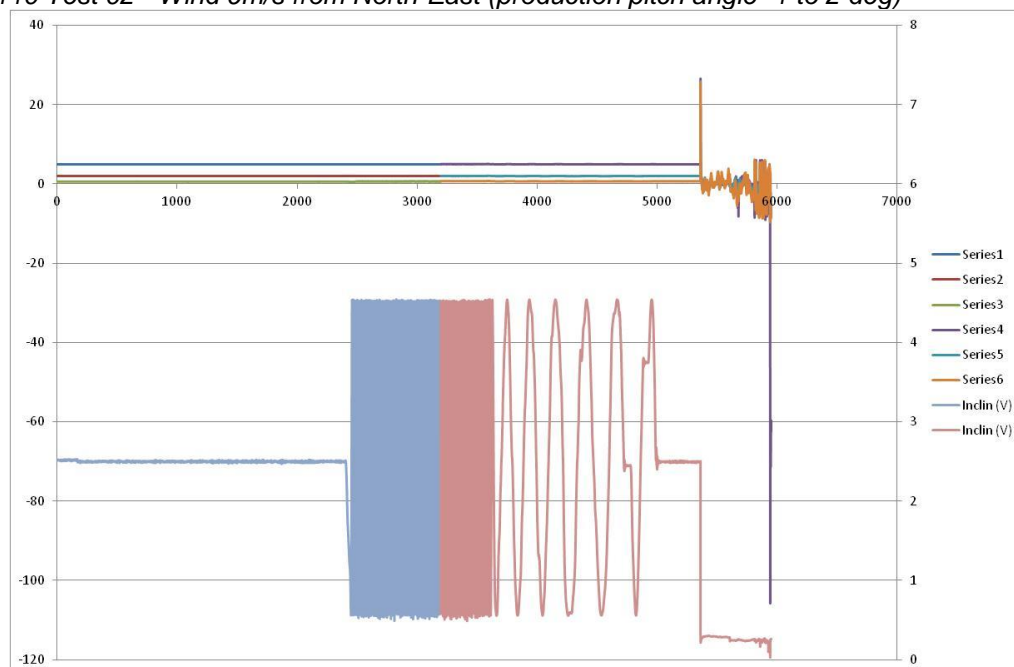
Fig. 70 – Main trace for the 130110 Test 2 showing the full acquisition period

There is a long pause before the turbine begins at autorun condition about 2400s into the acquisition period. When the autorun stops at about 3600s the turbine idles for some time before rotation is halted at 0° and the instrumentation system removed.

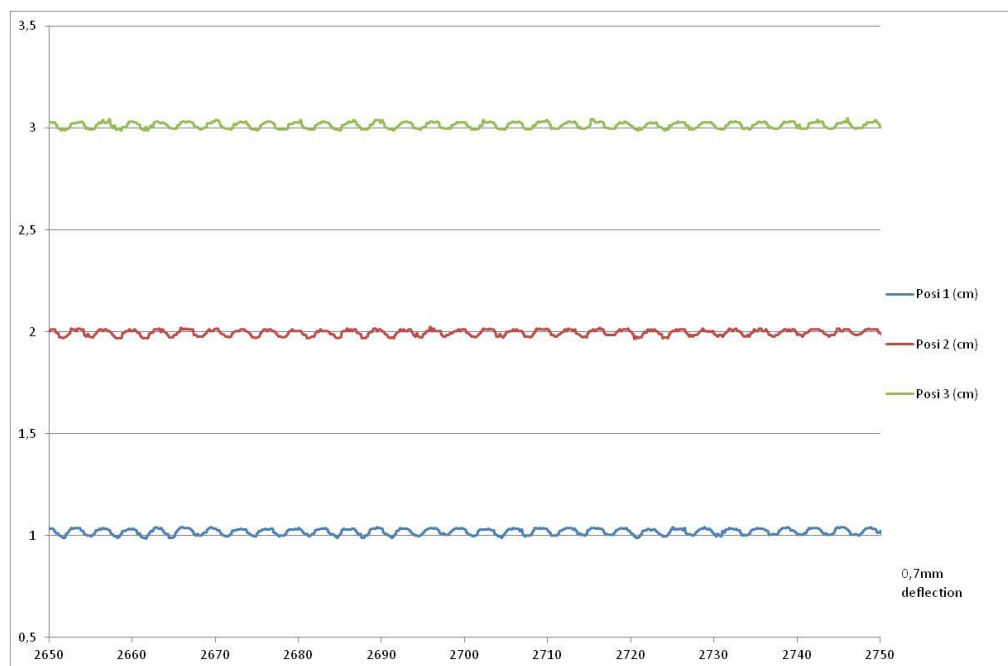
Fig. 71 – Close up detail of the posiwire response during autorun condition

A reduction in total deformation of 6.5 to 10mm between the two trailing edge panels to below 1mm in the reinforced blade was measured by these trials. The load value fluctuations measured between the trailing edge panels varied between 100 and 200N during autorun condition. And a cross shear beam distortion averaging 9mm was measured by the position wires at blade R 10m.
